# The Chart House Restaurant, Charleston, SC

Architects/Engineers: Cummings & McCrady, Inc. Charleston, SC  
Contractor: Whalley Construction Co.

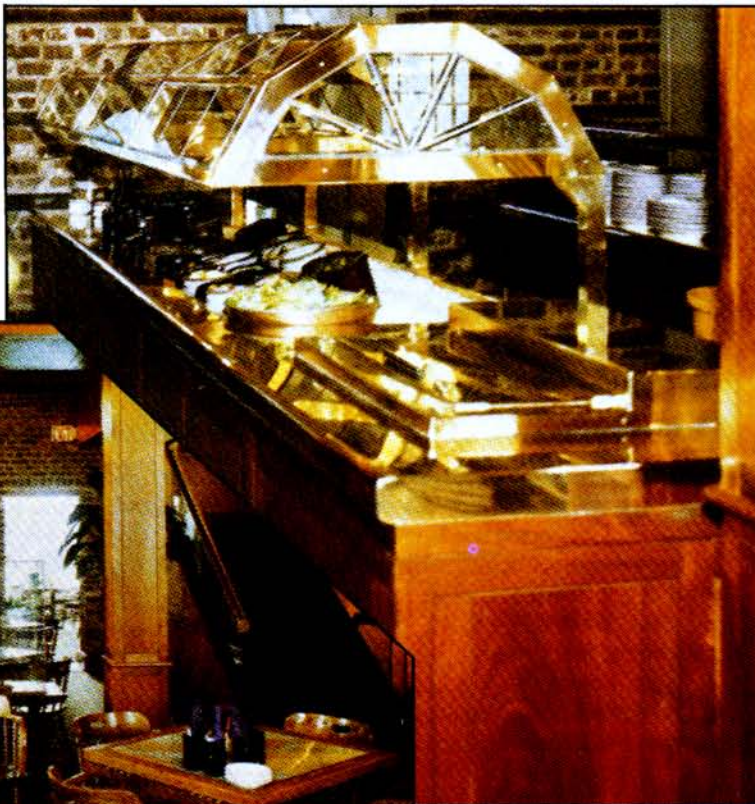
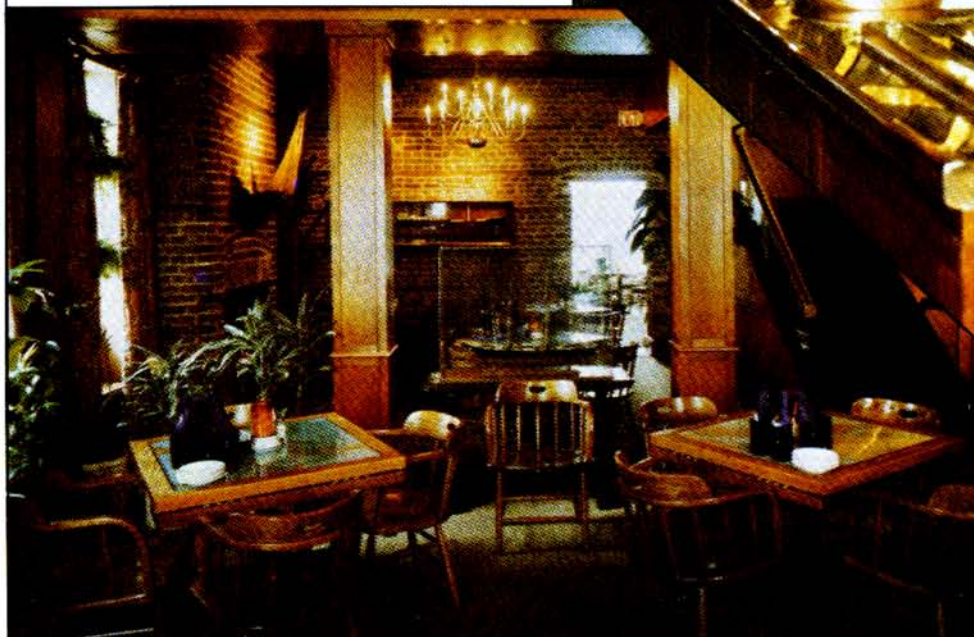
*Below and right: The use of brass and mahogany was to recall the feeling of the traditions of the old buildings in Charleston and also of fine old yachts.*

The salad bar uses the same paneling, but it also includes a

polished brass top and ice well. The sneeze guard (a state health requirement) is crafted from solid polished brass tubing which is cantilevered from the back of the salad bar. The tubing is then infilled with beveled edge glass in lead framing. The ends of the sneeze guard recalls the traditional fan lights over many of the entrances to Charleston houses.

The paneling is of mahogany. It is detailed with rails and panels to give it the scale of traditional paneling; however, all of the pieces are flush jointed with only  $\frac{1}{8}$ " grooves for relief rather than having "raised" or moulded joints. □
